Quassaick Creek Watershed Alliance

QC below Brookside Ave-Winona Lake

Date: Feb. 22, 2012 Time: from 1:30 to 3:00 PM Air Temp: 50 plus

Stream Name: Quassaick Creek

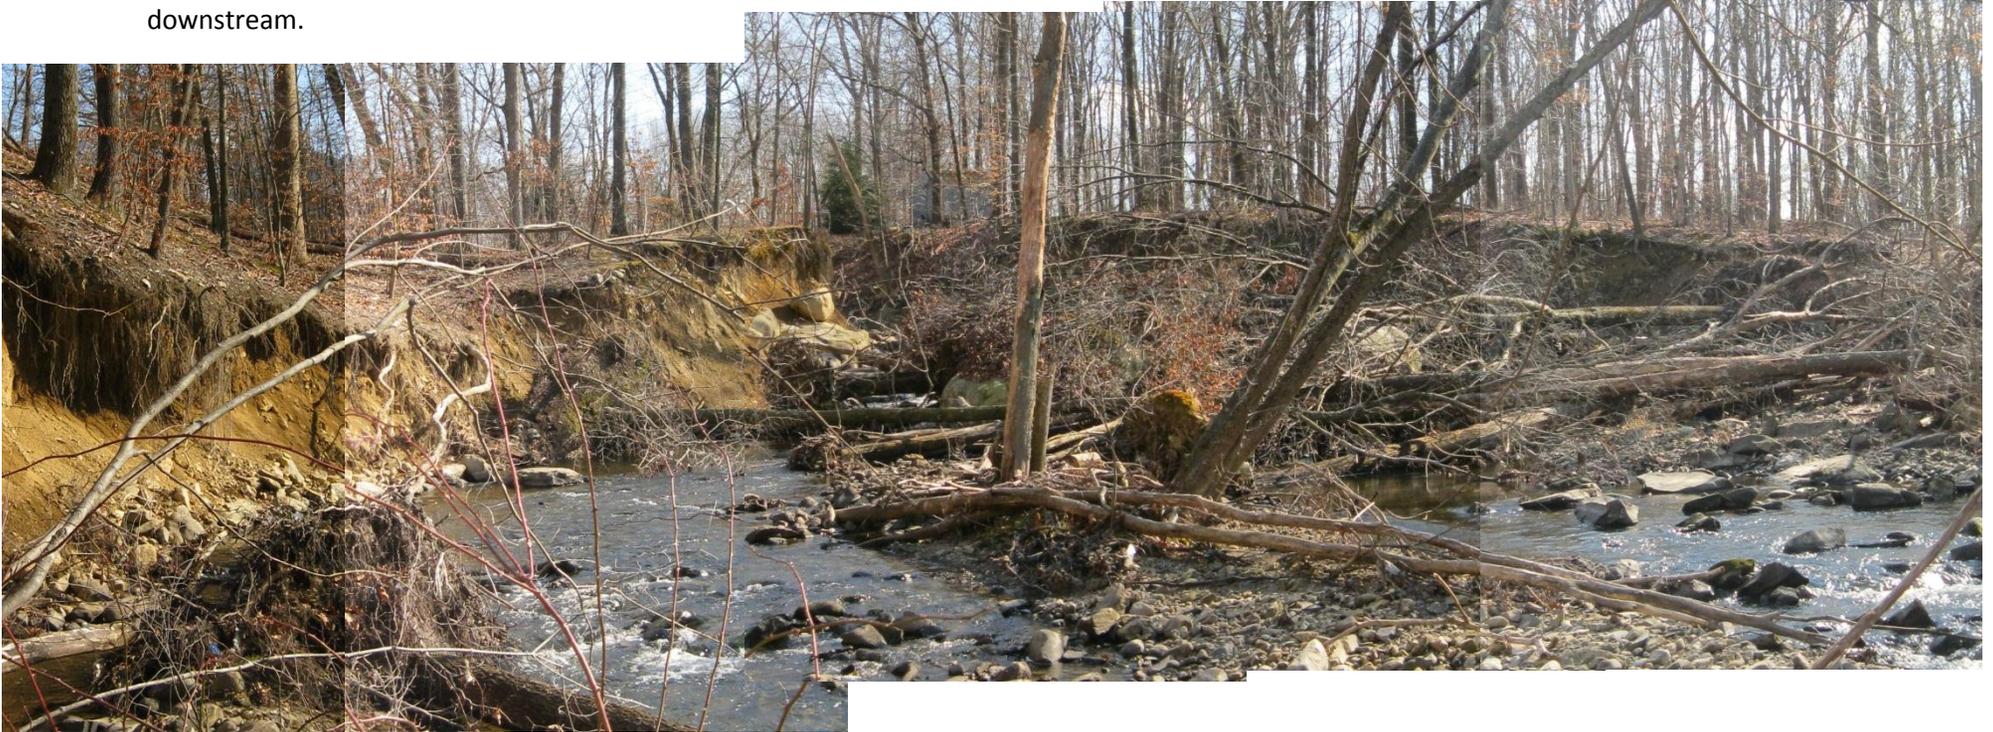
Erosion downstream from Winona Lake. The left side of the photo (right bank of stream*) is the downstream side of the Winona Lake Dam. In this photo Quassaick Creek flows toward the foreground. The stream flows between the small evergreen on the left bank, center photo, and the prominent boulder, just below the evergreen that is situated on the right bank.

View of Quassaick Creek looking up stream with the eroding back side of the dam on photo left.

Recommendation: Establish a base line along the top of the dam and measure distance to the edge of the eroded bank. Map the location of trees on bank and periodically document by re-measuring and photos any further erosion progress. Establish similar monitoring on opposite bank (left bank).
