UNDERWATER INSPECTION

***Beaver Dam Lake Dam Low Level
Outlet Valves***

***Beaver Dam Lake Dam
Salisbury Mills, NY***

March 29, 2006

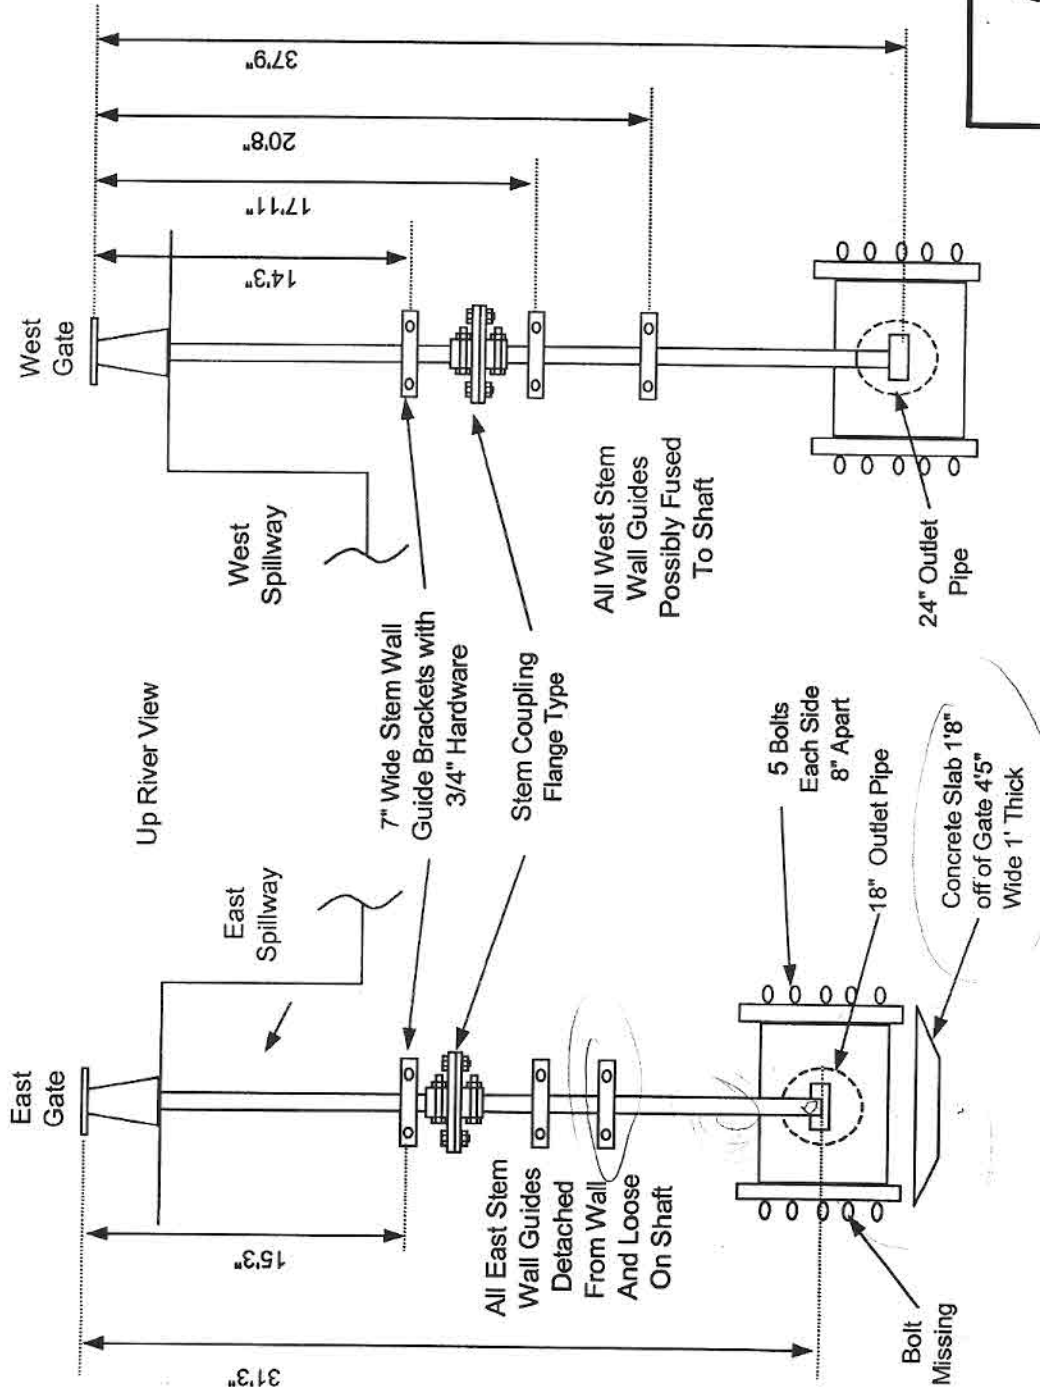
Beaver Dam Lake Dam Low Level Valves Inspection

- 1) Lower stem nut estimated at approximately 2-3/4 to 2-7/8"
- 2) East Gate - Track Width = 2'3", height = 3'2" -Noted to be in good condition and mounted to embedded timber.
- 3) West Gate - Track Width = 2'3", height = 2'9" -Noted to be in good condition and mounted to embedded timber.
- 4) Stem wall guides note to be approximately 7" wide with 3/4" hardware and in poor condition.
