**Appendix: Moodna Creek Dam Removal
New Windsor, NY**

Design Report

DRAFT FOR REVIEW - February 25th, 2008

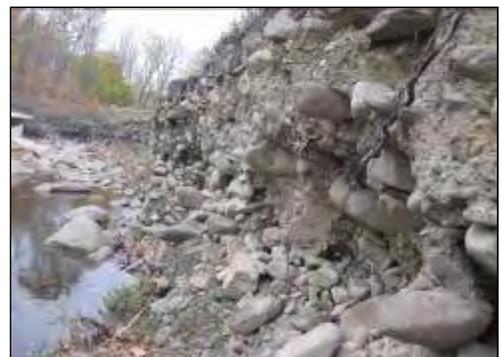
Figure 5. Eroding bank approximately 50 feet downstream of the dam removal project area

Bank Erosion Area – The bank downstream of the removal project area consists of loosely consolidated gravel and cobble till with two layers of compacted fill making up the top two feet of the bank (Figure 5). This exposed bank is currently vertical or with a negative (concave) slope directly in the hydraulic path of large floods. The site characteristics make this bank highly susceptible to erosion from snowmelt and storm flood events. Figure 6 shows the potential meander limits for Moodna Creek in the project area. It should be noted that this is an approximation of *potential* meander limits based on available soils information, geomorphic reconnaissance, current bank stabilization and topographic data. Bedrock outcrops bound

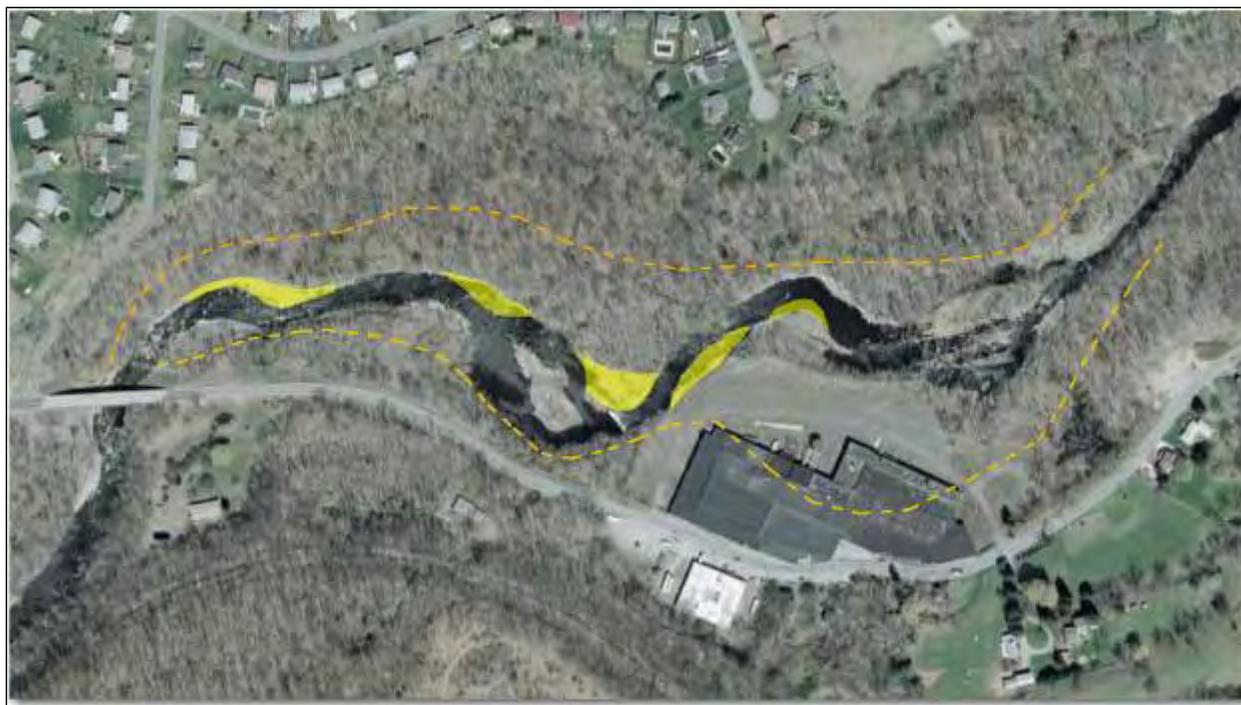
Figure 6. Aerial photograph of the Moodna Creek Dam removal project area. Approximate potential meander limits are shown as dashed orange lines. Areas of recent soil loss due to floodplain and bank erosion in 1999 and 2007 are shown in yellow.

the right bank on the Forge Hill Road side near the dam, and the historic valley wall is approximately 100 feet to the north of the current left bank. The areas of potential migration are limited to historic floodplain areas at the lower elevations. The meander limits shown are not the product of a full meander limit study, which would require more intensive soils and geotechnical investigation, and should not be used for planning purposes without validation.

It is difficult to determine a base rate for bank retreat or meander migration, but recent floods have resulted in the right bank of the channel moving approximately 38 feet toward the existing buildings on the right bank downstream of the dam. Examination of bank vegetation, bar development and erosion indicates that various sections of the channel downstream of Forge Hill Road have moved from 60 to 140 feet during single events. The channel throughout the reach is self armoring at the toe, as large cobbles and boulders tend to drop out to the angle of repose during smaller flood events, as finer sediment is winnowed from the upper banks.

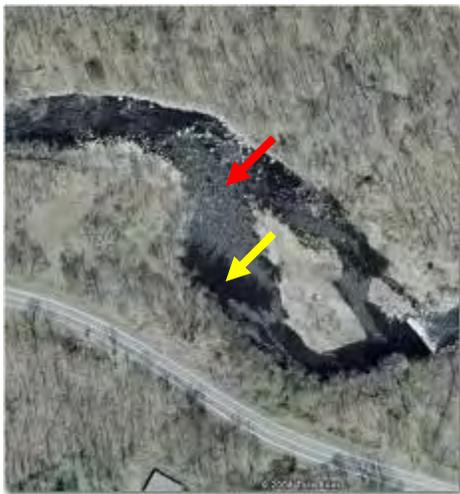
Figure 7. Moodna Creek showing historic riffle (red arrow) and scour pool (yellow arrow) locations

Bed material is usually sorted so that the smaller grains are transported further downstream whereas the larger grains are deposited first. This generally held true for the sediment in the impoundment of Moodna Creek. The majority of samples with an armor layer characterized by small cobble are located within the upstream half of the study area and the sample with the largest grains, sample 600 is located furthest upstream. This upper impoundment area is the historic riffle location and was the thalweg area prior to the dam breach, and thus sediment sizes here may be a more a reflection of historic riffle armoring than differential sediment deposition patterns caused by the dam (Figure 7).

upstream end of the sediment depositional area appears to be a remnant riffle, with its crest elevation is approximately 5 feet above the height of the dam. A deep scour pool remains at the downstream end of this riffle (Figure 7). The dam protrudes only 2-3 feet from the channel bottom, and is causing local scour, deposition and avulsion effects similar to those seen around large woody debris, in this case a single large log. Removal of the dam will have some local influence on channel movement. Most likely, the channel will resume its course toward the right bank, but the split flow will be maintained for an indefinite time.
